A CHANGE OF SCENE: HOW THE CANTERBURY EARTHQUAKE SEQUENCE LED TO A DEPARTURE FROM CONCRETE TECHNOLOGIES

Morten Gjerde¹

School of Architecture, Victoria University of Wellington, P.O. Box 600, Wellington, 6140, New Zealand

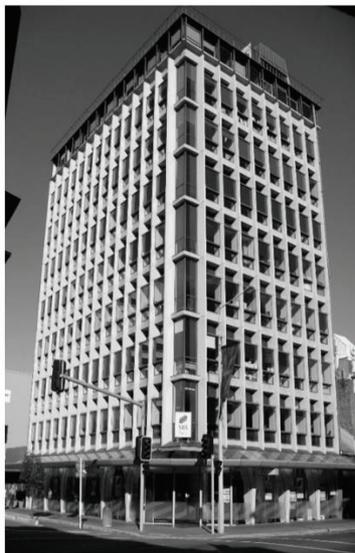
Figure 1: The Manchester Unity building by the architect Peter Beaven

In 1964 Peter Beaven broke new ground on several fronts when designing the Manchester Unity building on the corner of Worcester and Manchester Streets (figure 1). He conceded that it was the first time he had consciously addressed the local context and in this case his design referenced Mountfort's Trinity Congregational Church on the opposite corner. The project was built using the lift-slab method, innovative at the time in Canterbury although its use was short-lived (Gatley 2008). The key design feature developed by Beaven to link this building with the Trinity Church were the articulated precast concrete mullions, which extend the full height of the street facades. The depth of

the mullions allowed the architect to manipulate the alignment of the glazing and the floor structure over the height of the façade. This articulated façade contrasted with thin curtainwall systems being used elsewhere at the time.

With a generous, largely glazed ground floor and copper clad roof the building adopted the classical tripartite composition. Along the shopfronts the design revealed ‘Y’ shaped columns, which were used by Beaven to ‘collect’ adjoining pairs of mullions from the upper levels, and running them to the ground. With this building Beaven provided punctuation to an important corner of this gridded city. He also brought a sense of European elegance to Christchurch (van Raat 2005) but tempered this through references to local buildings and by using his beloved precast concrete innovatively.

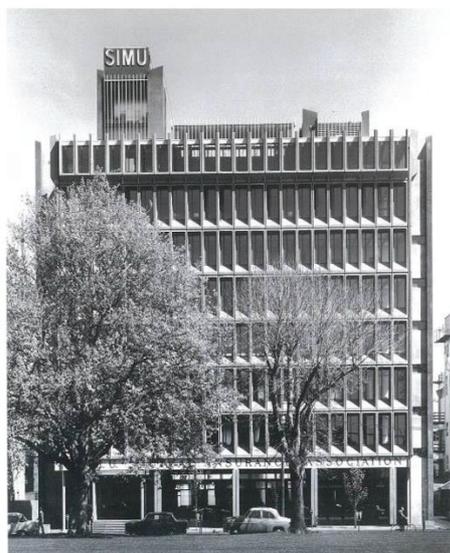
Figure 2: The SIMU building by the architect Miles Warren

The structural solution for the SIMU building, designed for a site facing onto an important public square in the city, adopted Lyall Holmes’s technique of concentrating lateral support into a stiff core - in this case two cores - allowing the outer columns to be relatively light as they were only required to support gravity loads (Warren 2008). Spanning between floors, the precast concrete cladding panels used at SIMU had an exposed aggregate finish and adopted tight rhythmic spacing. While Warren remained committed to the expressive potential of roofs in the Canterbury landscape, SIMU was given a light, almost ethereal conclusion. The vertical mullions of the panels below stretch upward causing the building to literally merge with the sky.

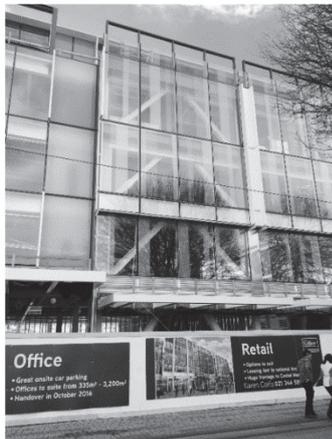
Figure 3: Like many new buildings, the steel structure is clearly expressed in the facade design.

It is clear now that the lineage of concrete technology that could be traced through buildings dating to different eras has been abruptly stopped though the invisible hand of the market. As the rebuild has taken shape it is now obvious that building owners and designers have been almost universally attracted to glass and steel (Marshall, Sheppard *et al.*, 2016). While this attraction has undoubtedly been fuelled by global fashion, the manner and consistency with which braced steel frames are celebrated in the new building facades suggests that architects seek to send a not-too-subtle message to potential occupants: “This building’s structural design has been given top priority”. The emerging Christchurch style can be attributed to what urban designer Hugh Nicholson calls corporate urbanism, where the goal of attracting tenants in the current market leads to the expression of seismic engineering features. See figures 3 and 4. This opinion was confirmed by property developers and owners, who are aware that safety and resilience are now much higher on the list of tenant needs than they were prior to the earthquakes. These demands are fuelled by tenant organisations aims of attracting and keeping high quality staff and enabled by the current competitiveness in the market as property owners seek to attract tenants. In this context, it is about perceptions as much as it is about demonstrated performance. Residual concerns about the performance of concrete have led the market away. Property owners’ motivations toward steel structures complement those of the designers consulted in this research. They expressed strong preferences to explore lightness, crispness and transparency in new buildings, qualities that glass and steel make possible. The architects expressed low regard for the earlier character of the city, noting that with so much of it gone there is an opportunity to create a new visual environment.

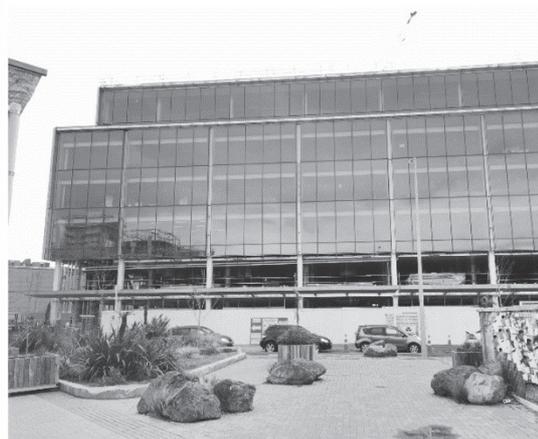
Figure 4: The glass facades of most new buildings lack the articulation and visual interest that was a hallmark of concrete facades in the city prior to the earthquake sequence.
